GEOTECHNICAL REPORT

GEOTECHNICAL RECOMMENDATIONS & GEOLOGICALLY HAZARDOUS AREAS ASSESSMENT

Proposed Parking Garage and Surface Parking
Saint Edward Seminary
Kenmore, Washington

PROJECT NO. 16-163
June 2016

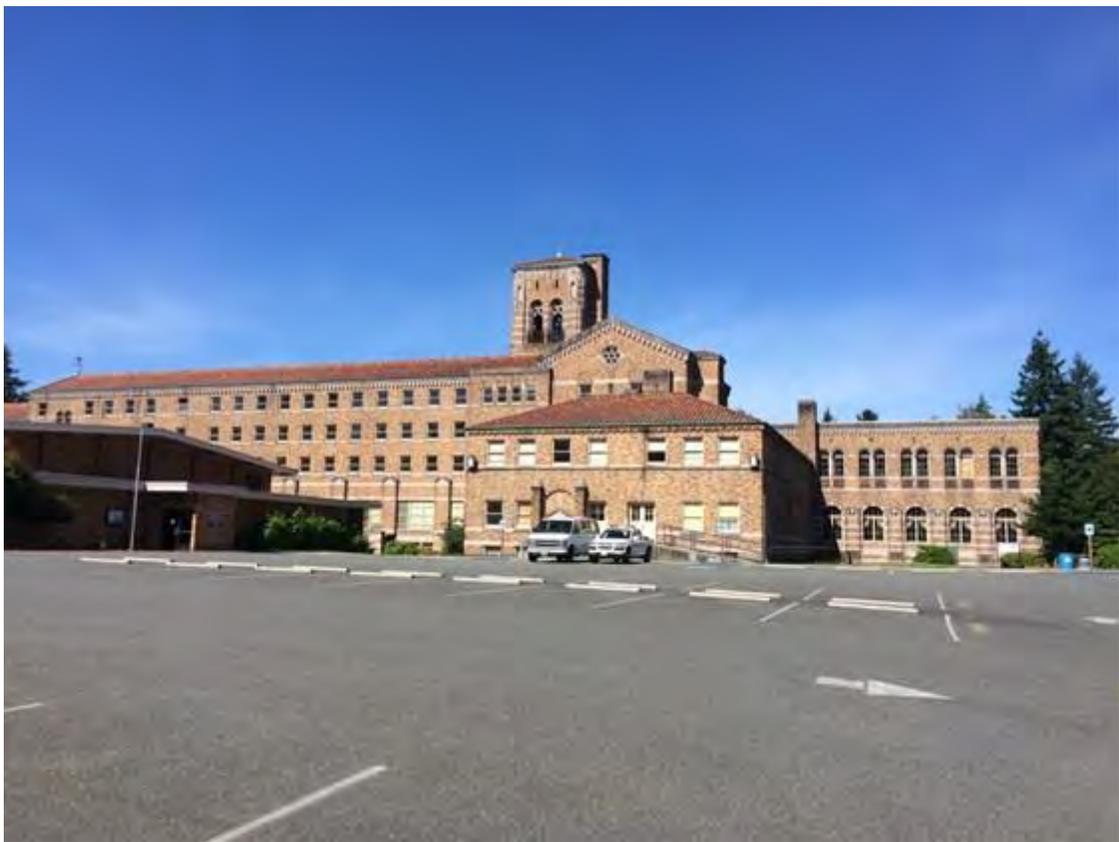
Plate 1: View of proposed parking garage location. The former seminary building is located in the background. The Wald Pool is located on the left side of photo.

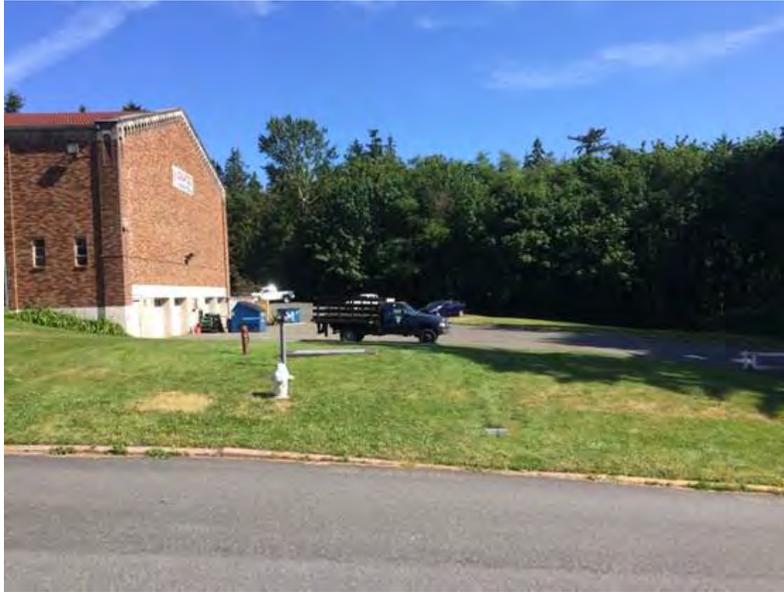
Plate 2: View of proposed parking area to the northwest of the existing seminary building.

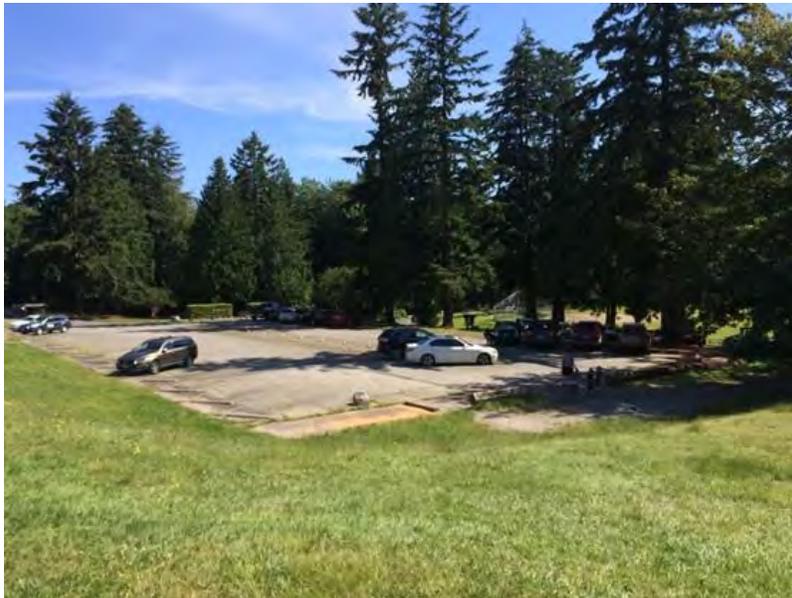
Plate 3: View of planned parking area east of the former seminary. The below grade parking structure will be located just left of view in photo.

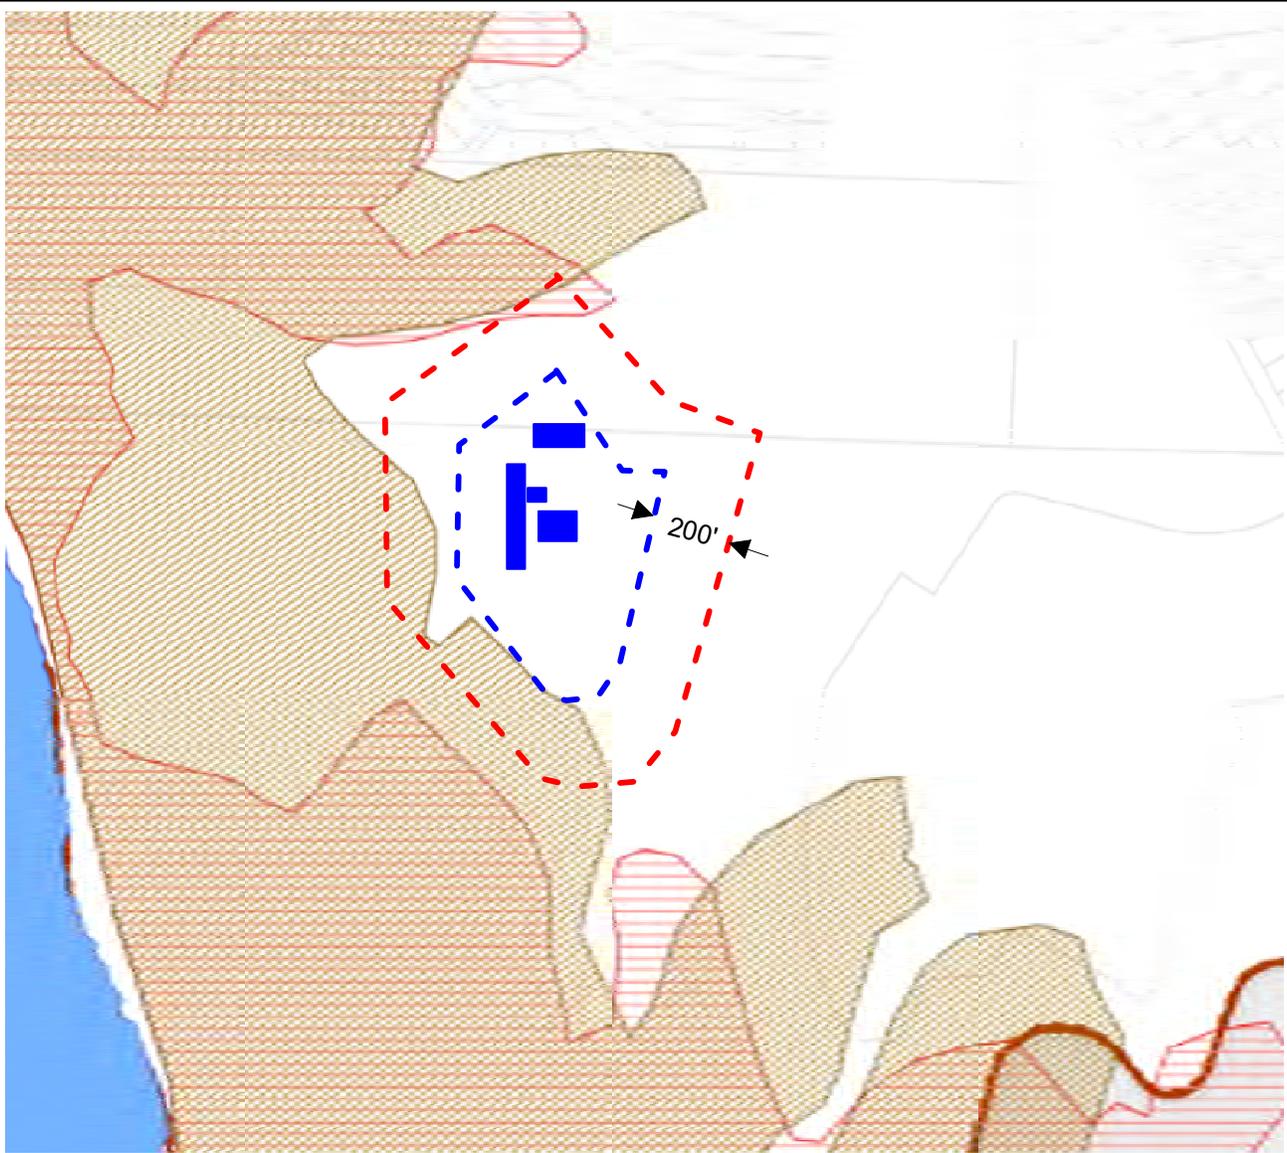
Figure No. 3

Saint Edward Park contains steep slope areas that meet the City of Kenmore criteria for geologically hazardous areas due to erosion and landslide hazards. The approximate extent of the erosion and landslide hazard areas, relative to the proposed area of improvements, are shown on the attached Figure 3.

Based on our review, the area of the proposed improvements does not contain areas meeting the City of Kenmore definition of a landslide hazard area. The slopes of the steeply incised stream channel to the north and south of the planned improvements would meet the criteria for landslide hazard areas, however, the planned improvements will be situated more than 150 feet from these areas. This distance exceeds the minimum landslide hazard area setback requirements of 50 feet identified in the KMC.
